**Shock and Vibration Qualification Testing
For
FCC8/FSC8**

Test Report

Report No.: SZER100226117714E-R1

Sample Name : Connector
 Sample Description : Normal
 Part Number : FCC8-20-01-L-S-A/FSC8-20-01-L-S-A
 Amount of Sample : 12 pcs
 Sample Received Date : Mar. 01, 2010
 Sample tested Date : Mar. 19, 2010~Mar. 27, 2010

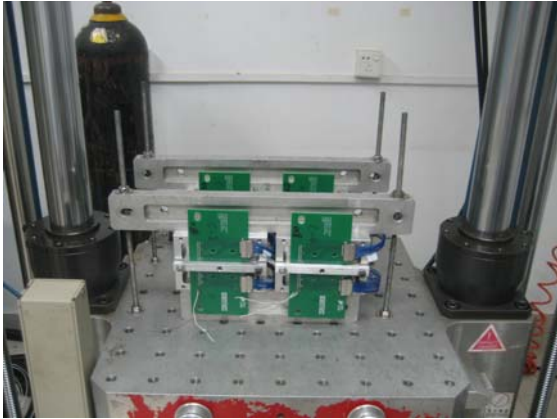
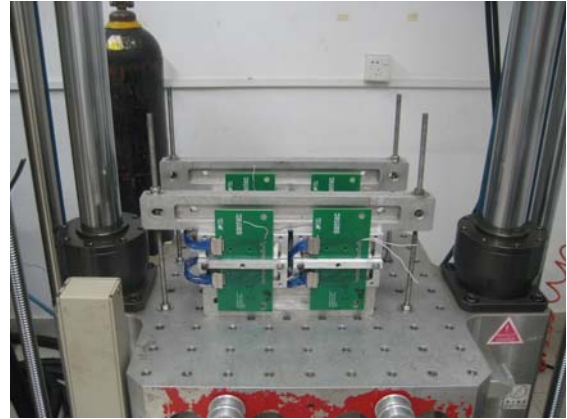
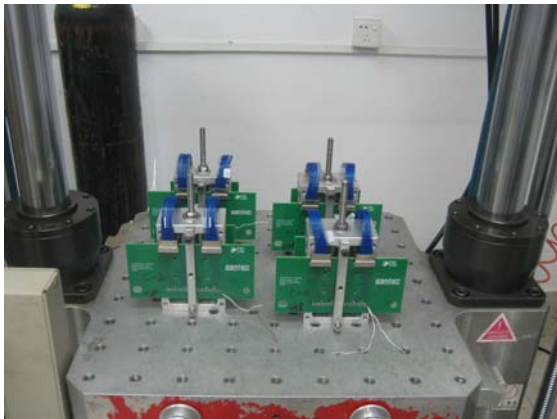
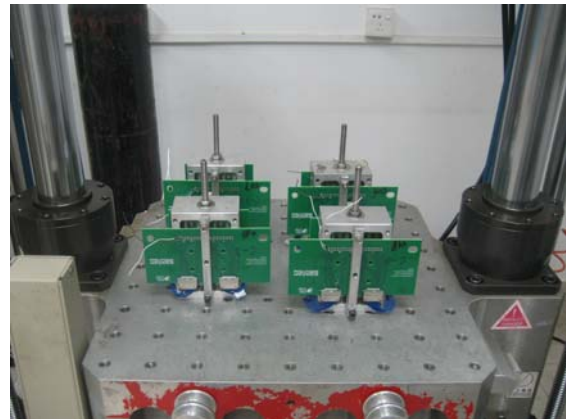
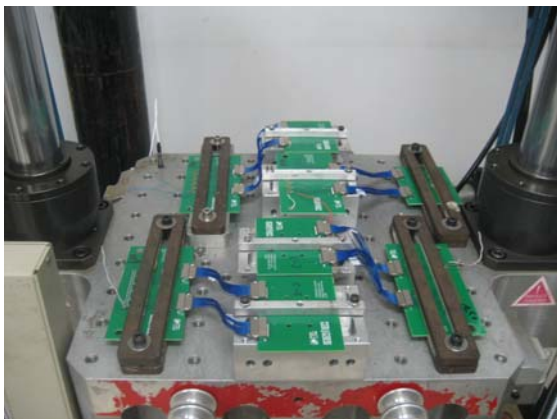
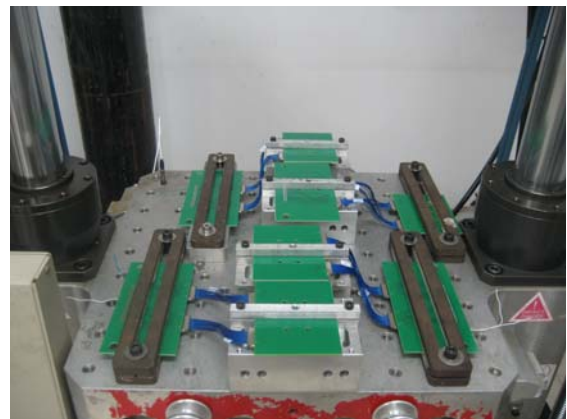
Test Photos:

---Wave form: Half-sine

---Acceleration: 100 g_n

--- Pulse duration: 6 ms

---Direction: Axis ±X, ±Y, ±Z

---Number of shocks: 3 shocks /axis, 18 times in total

Test Results: There was no physical damage to the tested samples after the test.

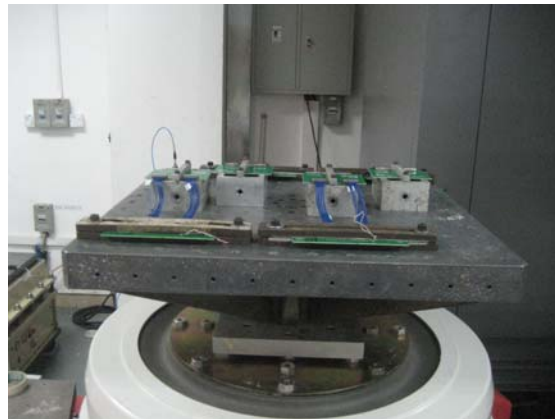
Test Photos:

Frequency (Hz)	PSD (g^2/Hz)	Slope (dB/oct)
50	/	+6
100-1000	0.04	/
2000	/	-6

---Acceleration: 7.56 Grms

---Direction: Axis X, Y, Z

---Test duration: 2 hours/axis

Test Results: There was no physical damage to the tested samples after the test.

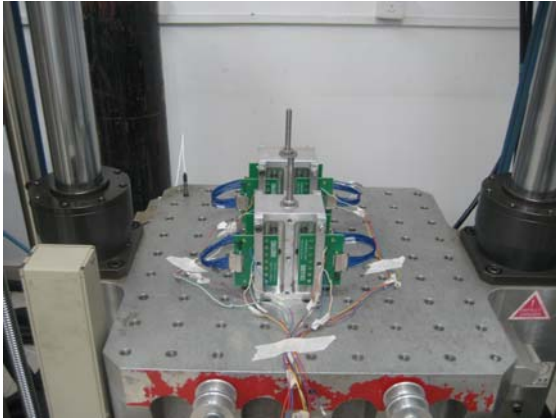
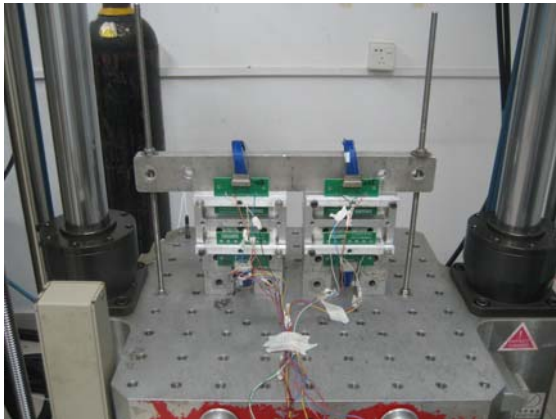
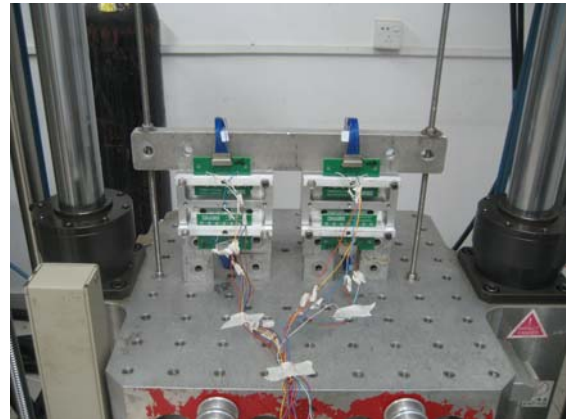
Test Photos:

---Wave form: Half-sine

---Acceleration: 100 g_n

--- Pulse duration: 6 ms

---Direction: Axis ±X, ±Y, ±Z

---Number of shocks: 3 shocks /axis, 18 times in total

Test Results: There was no evidence of physical damage to the tested samples, there was no low microsecond event detected greater than 0.1 microsecond. Other characteristics should be evaluated by the client.

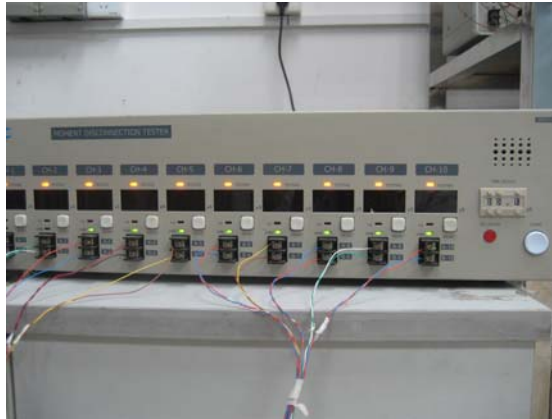
Monitor during the test

---Monitor the discontinuity duration of samples during the test

---There shall be no low microsecond event detected greater than 0.1 microsecond.

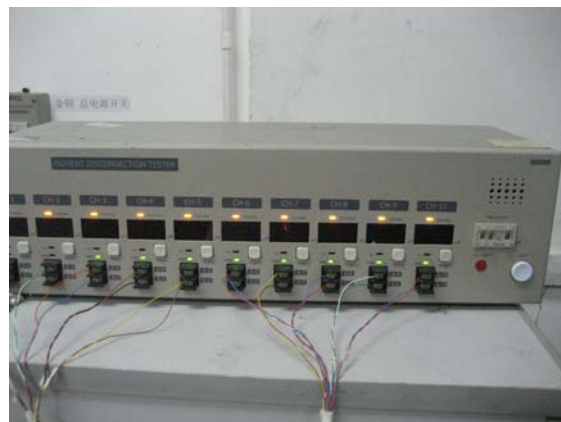
Monitor during the test

---Monitor the discontinuity duration of samples during the test

---There shall be no low microsecond event detected greater than 0.1 microsecond.
