TEST REPORT #208157

QUALIFICATION TESTING

ERF8-050-L-D-EM2
ERM8-050-05.0-L-DV

SAMTEC, INC.

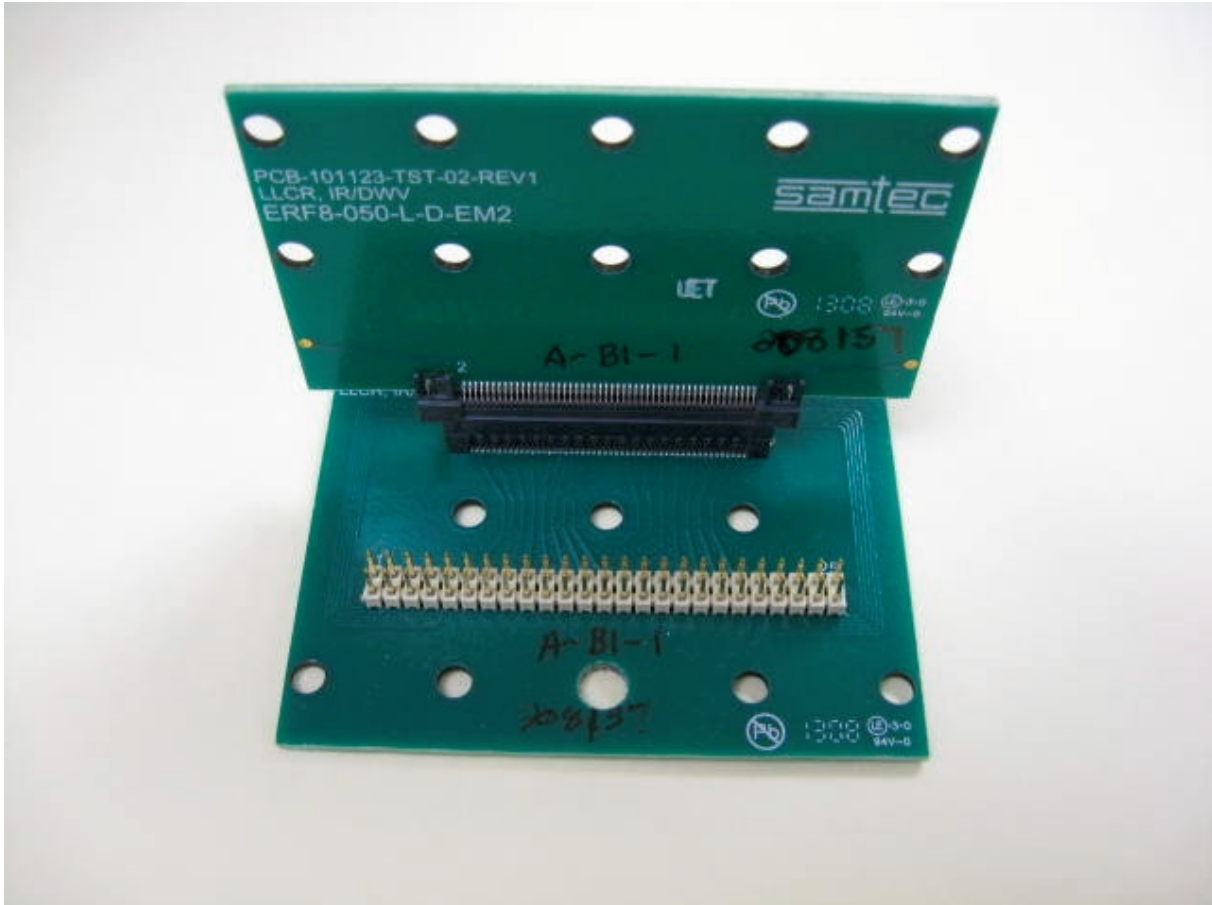
FIGURE #1

TYPICAL MATED TEST SAMPLE

2. Test samples were supplied assembled and terminated to test boards by the test sponsor.
3. Test boards for mounting test samples were supplied by the test sponsor.
4. Figure #1 illustrates the connectors used for test.
5. Test leads were attached to the appropriate measurement areas of the test samples and applicable mating elements.
6. The mated test samples were secured via a stabilizing medium to maintain mechanical stability during test.

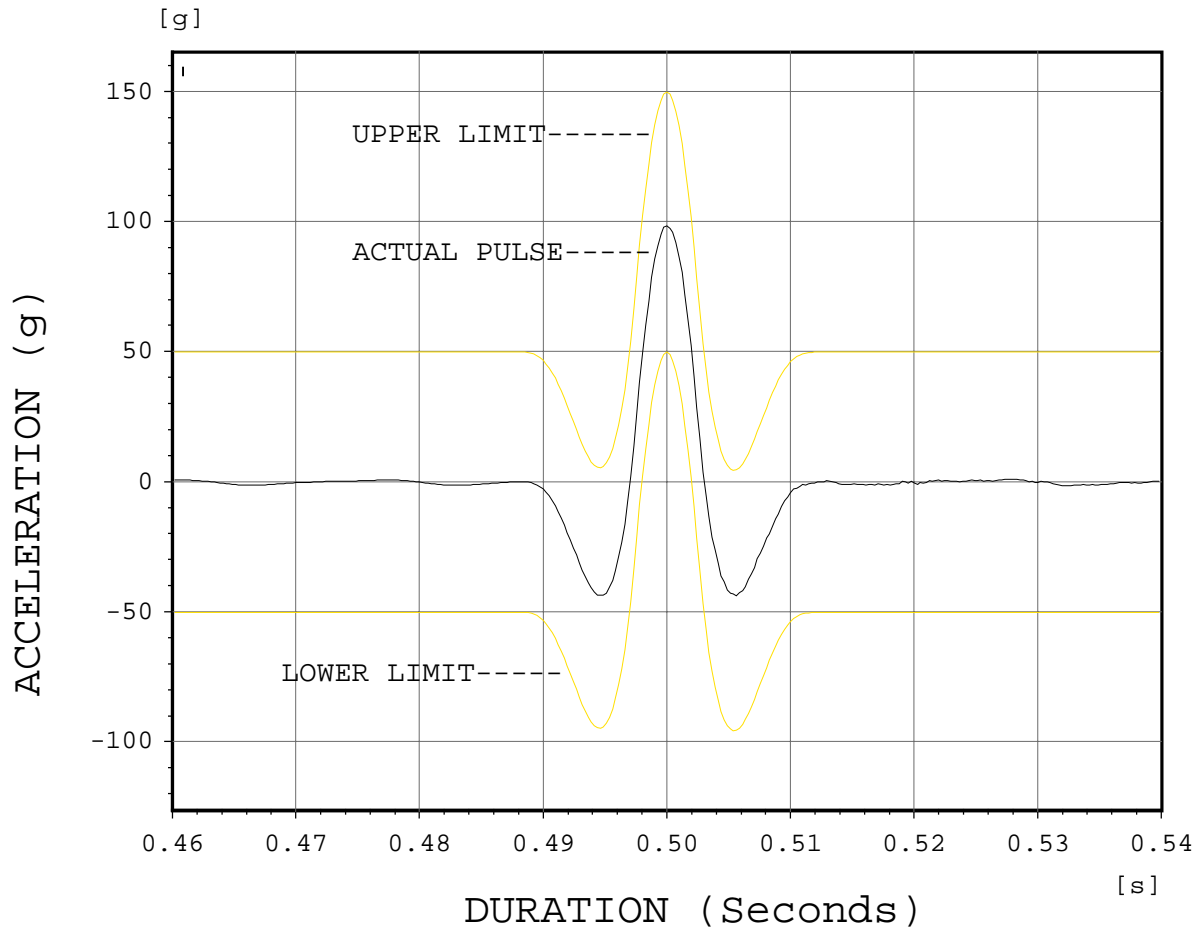
Classical Shock

Project 208157
Samtec
05-14-08
Actual Wave 1
100G's 6ms
Halfsine
Tech:DH

1. There was no evidence of physical damage to the test samples as tested.
2. There was no contact interruption greater than 1.0 microsecond.
3. The Mechanical Shock characteristics are shown in Figures #5 (Calibration Pulse) and #6 (Test Pulse). Each figure displays the shock pulse contained within the upper and lower limits as defined by the appropriate test specification.
