TEST REPORT #209281 & 209559

UPX SERIES CONNECTOR TESTING

PART#: UPT-08-01-L-RA
MATING PART#: UPS-08-01-L-RA

SAMTEC, INC.

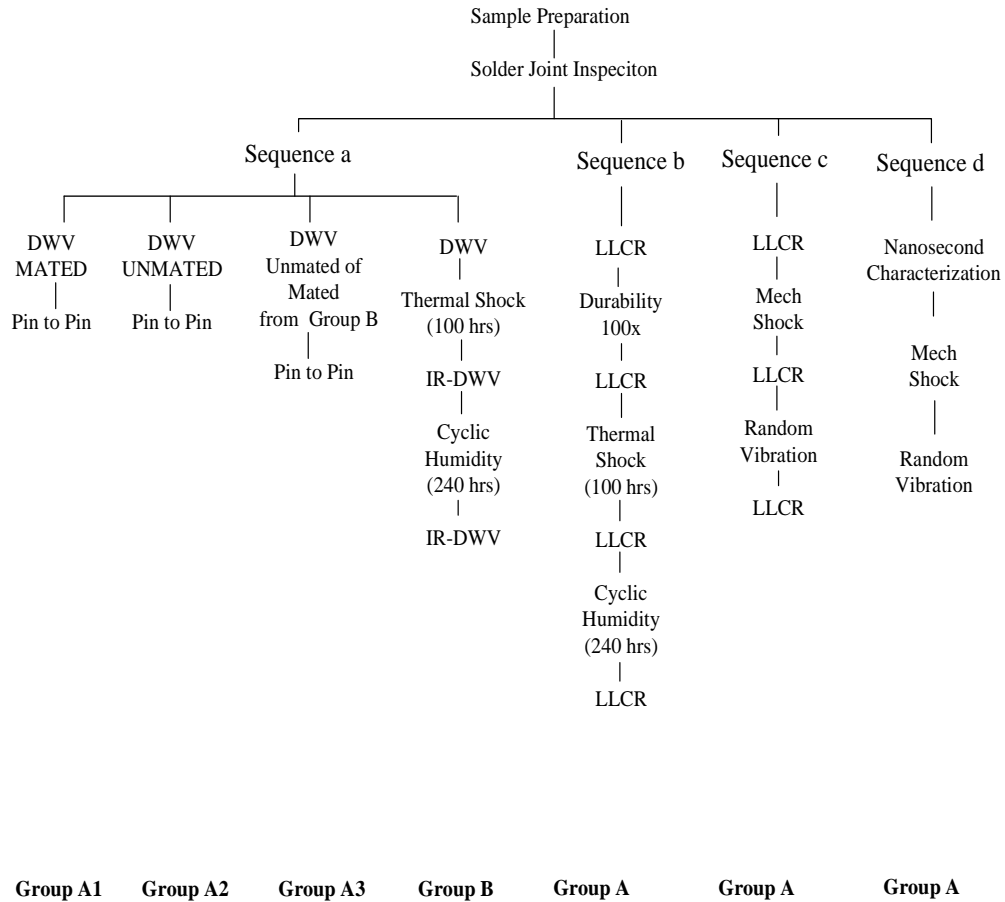
FIGURE #1

TEST PLAN FLOW DIAGRAM

IR : Insulation Resistance
 DWV : Dielectric Withstanding Voltage
 LLCR : Low Level Circuit Resistance

1. See Test Plan Flow Diagrams, Figures #1 for test sequences used.
2. Test set ups and/or procedures which are standard or common are not detailed or documented herein provided they are certified as being performed in accordance with the applicable (industry or military) test methods, standards and/or drawings as specified in the detail specification.
